SPOFFORD LAKE DAM

NH 00356

PHASE I INSPECTION REPORT  
NATIONAL DAM INSPECTION PROGRAM

NOVEMBER 1978

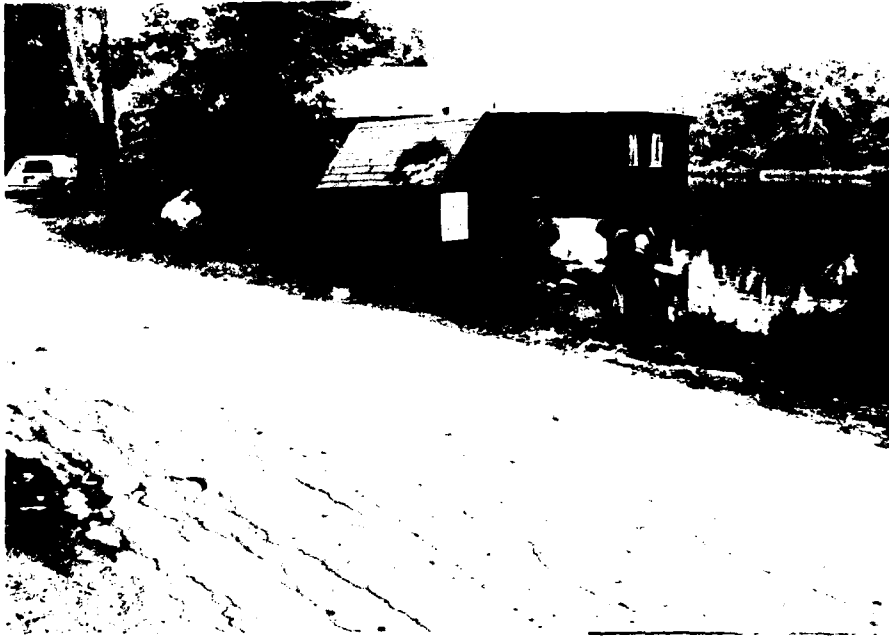
Overview of dam from left abutment showing  
gate house and approach channel

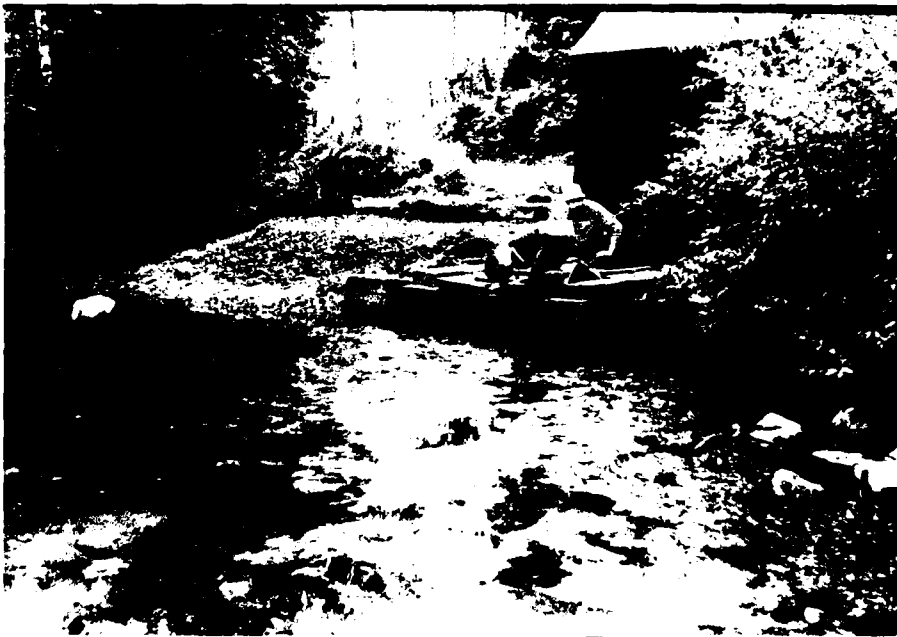
Overview of dam from right side upstream  
showing inlet area

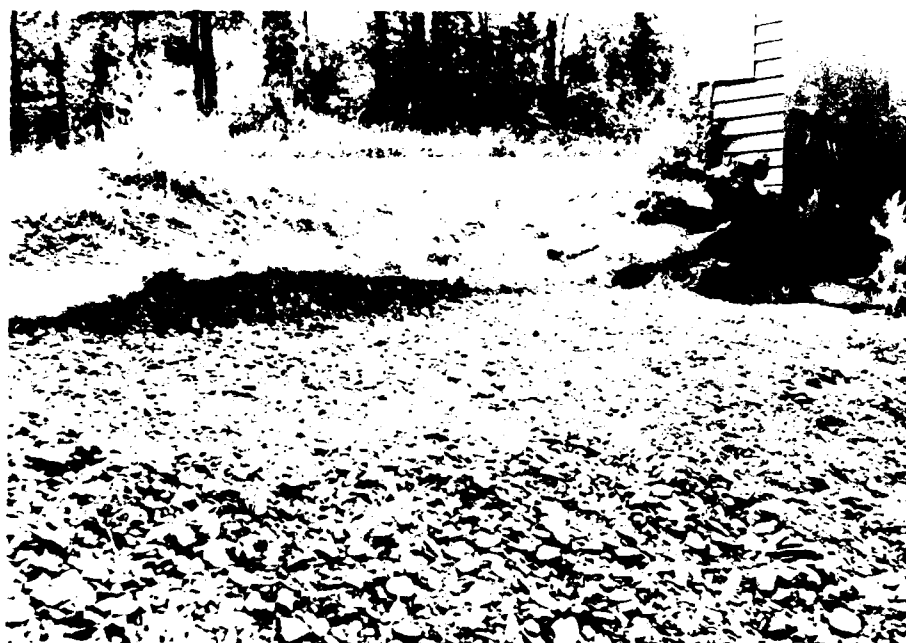
The upstream face of the dam is an 18 inch thick, vertical concrete wall, but gravel has since been dumped in front of the wall on the left side of the dam to provide fire trucks access to the lake for drawing water. Only 12 to 18 inches of concrete remains exposed on the left side, compared to 2 to 3 feet on the right. The top part of the left side of the wall is significantly deteriorated, partly by erosion and partly by trucks driving over it. A few voids up to 12 square inches in area and 2 inches deep were noted on the face. Evidence of erosion and spalling is present to a minor degree at joints, while aggregate has been exposed over 50% of the surface. Random hairline cracking is evident over most of the wall. The right side of the wall is in somewhat better condition, displaying only minor erosion and random hairline cracking. There is no evidence of cracking or sloughing of the fill near the upstream wall.

1. View of upstream concrete wall showing deterioration of concrete

The dam is in FAIR condition at the present time and requires some routine maintenance. Included in these O & M procedures are repair of deteriorated concrete, repair of erosion, removal and trimming of vegetation on the earth fill and in the downstream channel, removal of the inoperative sluice gate, cleaning of the concrete culvert, installation of a gage, institution of a formal record of operations and lake levels and establishment of an ongoing preventative maintenance program.

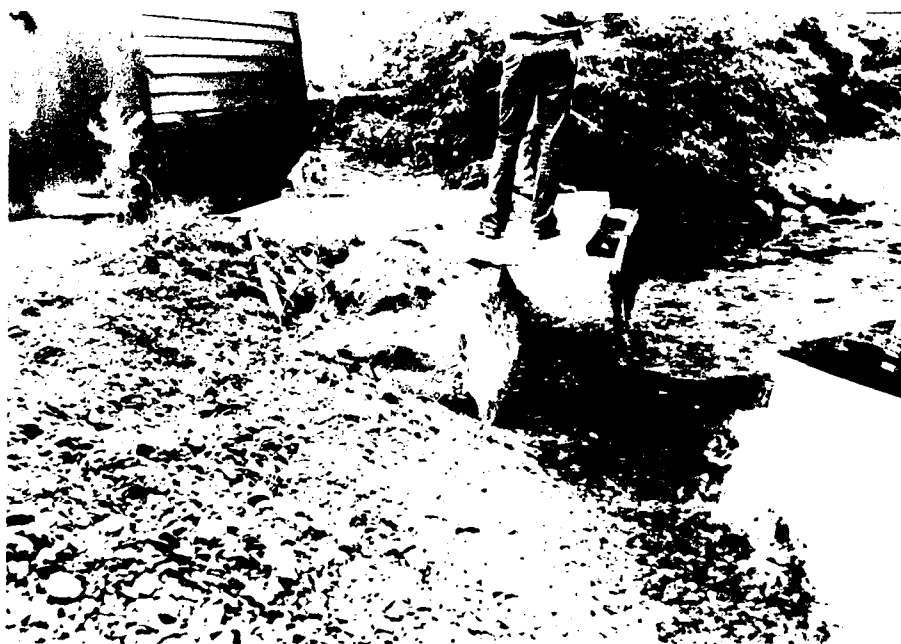
The two inlet walls are in fair condition despite surface erosion exposing aggregate, minor spalling, random hairline cracking and some deterioration at joints. The soil under the walls has been eroded to a depth of at least 6 inches.

The two smaller walls parallel to the front face of the dam display identical deficiencies. Erosion is occurring at the ends of these walls, resulting in 6 to 12 inches of the walls acting as a cantilever.

2. View of inlet area from left side showing erosion of concrete
